VOLUME I
FINAL REPORT
MATERIALS FOR ADVANCED TURBINE ENGINES (MATE) — PROJECT 3
DESIGN, FABRICATION AND EVALUATION OF AN OXIDE
DISPERSION STRENGTHENED SHEET ALLOY COMBUSTOR LINER

United Technologies Corporation
Pratt & Whitney Aircraft Group
Pratt & Whitney Engineering Division

National Aeronautics and Space Administration
Lewis Research Center
Contract NAS3-20072 Project 3

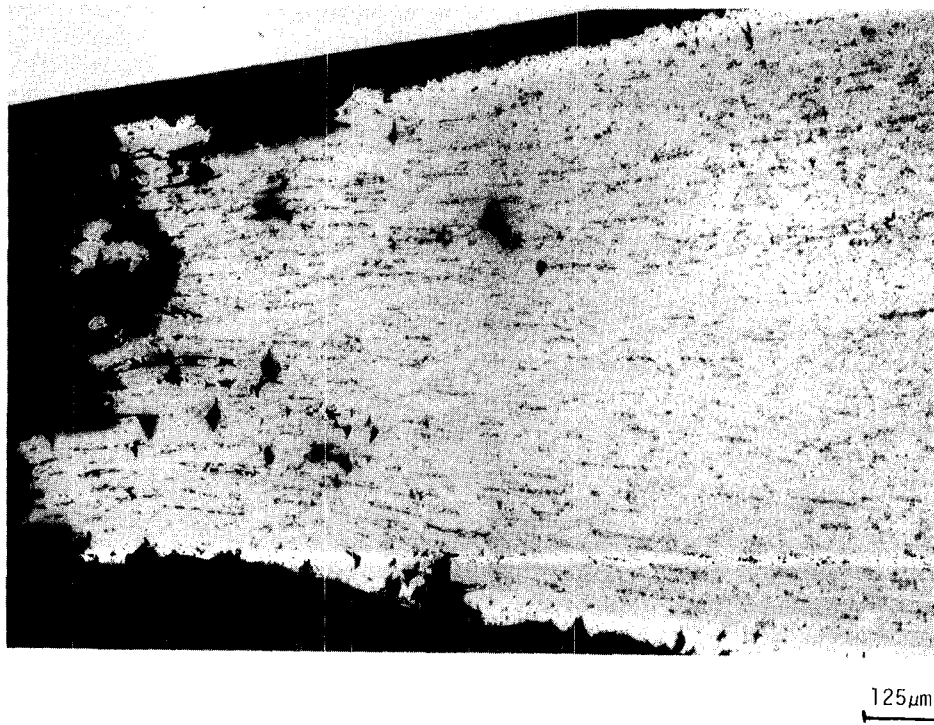
Figure 5-11 Fracture Appearance of HDA 8077 Lot MS 154 Creep Specimen Tested to Rupture in 14.7 hrs. at 982C (1800F), 89.6 MN/m² (13 ksi). Creep extension immediately prior to failure 1.84%; Rupture elongation 7.4%.

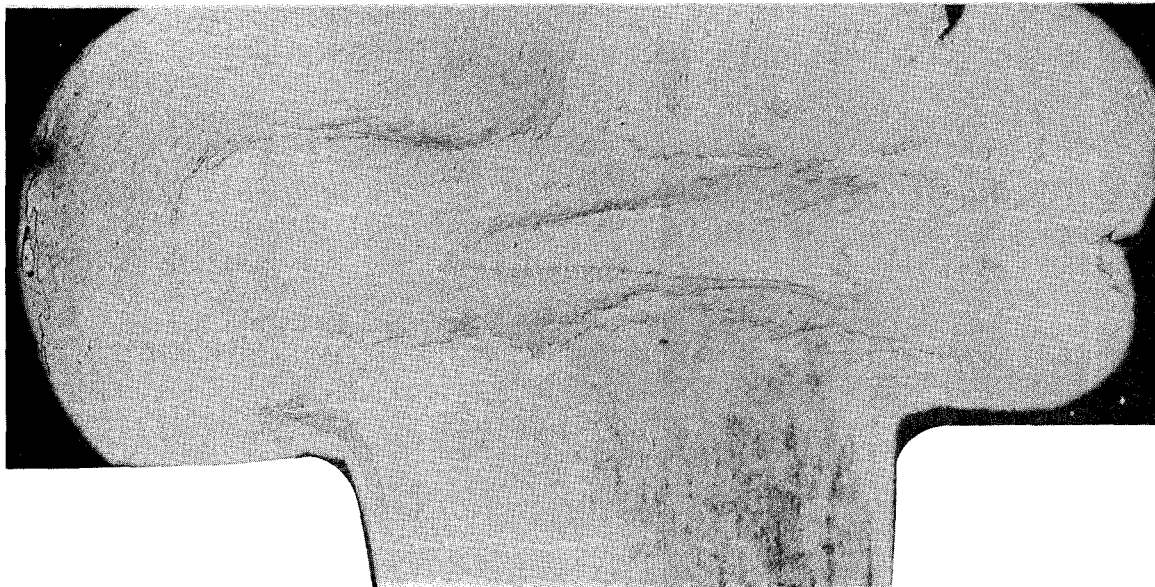
Figure 5-67 Microstructure Observed in Headed End of MA 956 Rivet
Fabricated From Lot ZDBC Bar Stock
